Project 82880.00  
30 July 2021  
R.031.Rev0  
MJH:bjk

**Routine Water Monitoring - June 2021**  
**EBH Waste Processing Facility**  
**60 Donaldson Street, Wyong**

## 1. Introduction

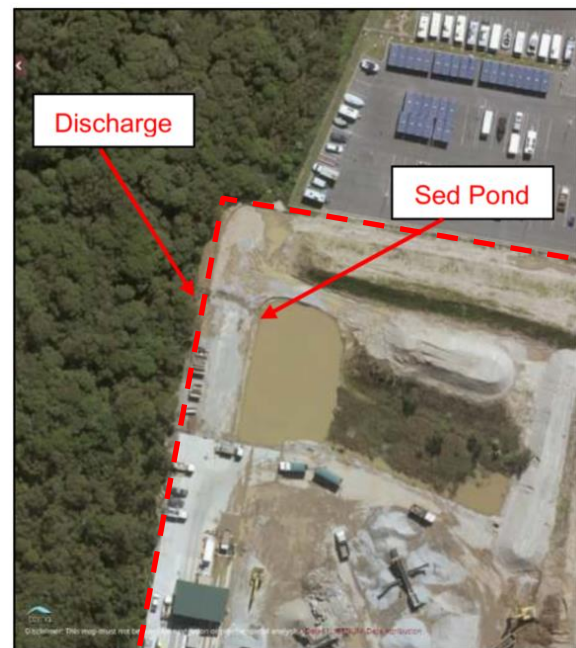
**Figure 2: Monitoring locations**

It is understood that the on-site sedimentation pond collects stormwater and general site run-off which discharges toward the western boundary of the site (refer to Figure 1). Monitoring was undertaken to assess the water quality of the sedimentation pond and at the point of discharge.

The approximate monitoring locations are identified in Figures 1 and 2.

The field work was undertaken on 23 June 2021 by Mr Brent Kerry (Douglas Partners). Visual inspection did not identify any obvious signs of potential contamination on the water surface. Water was observed to be discharging from the sediment pond through a rubble filled trench at the time of the sampling.
