EBH Environmental Services Pty Ltd
60 Donaldson Street
North Wyong NSW 2259

Project 82880.00
14 October 2022
R.040.Rev0
MJH:bjk

Routine Water Monitoring - September 2022
Recovered Aggregate Assessment Program
60 Donaldson Street, North Wyong

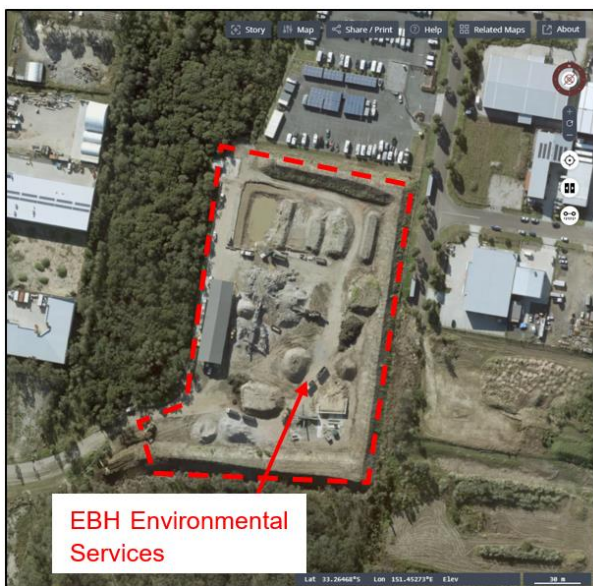
Figure 1: Site Locality

It is understood that the on-site sedimentation pond collects stormwater and general site run-off which discharges toward the western boundary of the site (refer to Figure 1). Monitoring was undertaken to assess the water quality of the sedimentation pond and at the point of discharge. It should be noted that water was not discharging from the pond at the time of monitoring (19 September 2022).

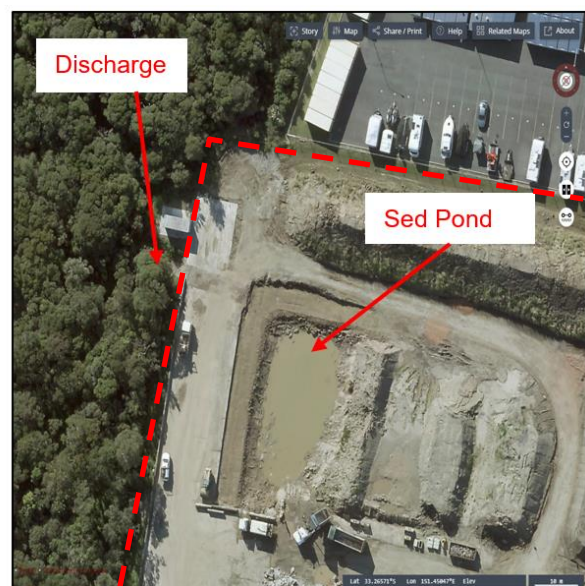
Figure 2: Monitoring Locations

The approximate monitoring locations are identified in Figures 1 and 2.
